Fukushima - Update November 2011

Fukushima Update 1/11-11

VBR seminar 15. november 2011, DTU Risø campus

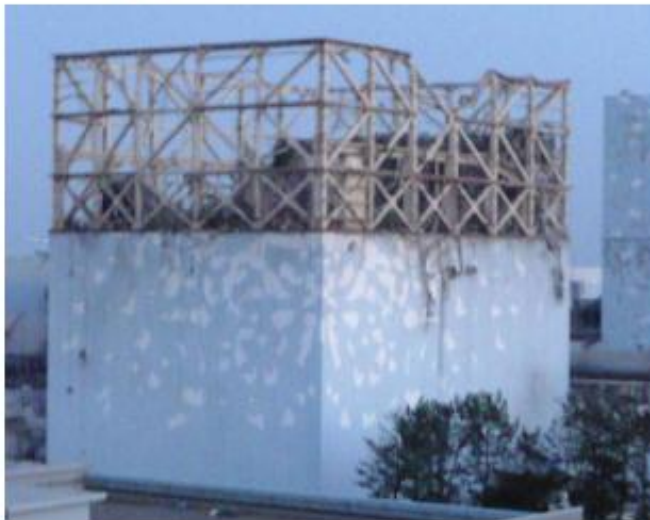
► Unit 1 und 3

- ◆ Hydrogen burn inside the reactor service floor
- ◆ Destruction of the steel-frame roof
- ◆ Reinforced concrete reactor building seems undamaged
- ◆ Spectacular but minor safety relevant

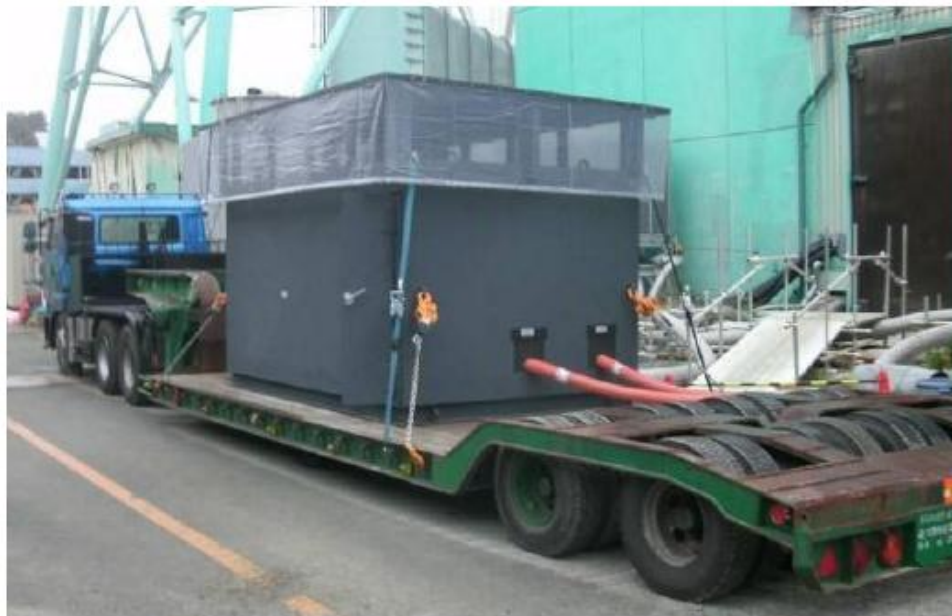
Figure 4: Caesium absorption apparatus inside shielding container

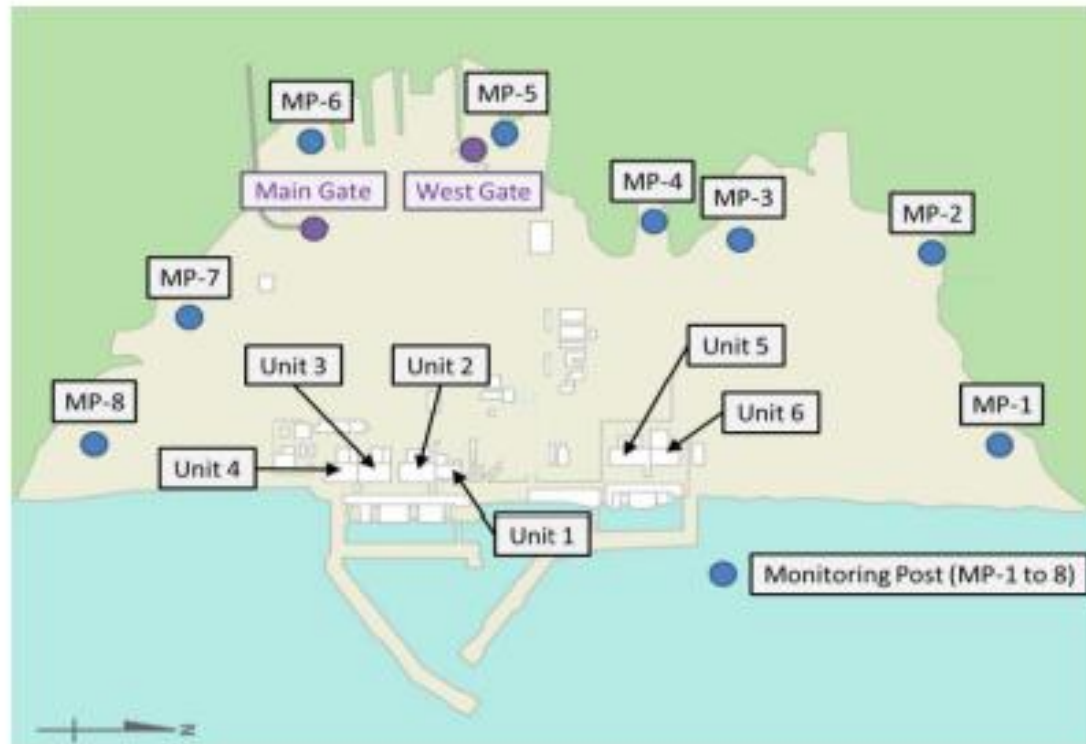
Figure 8: Onsite monitoring posts at Fukushima Daiichi

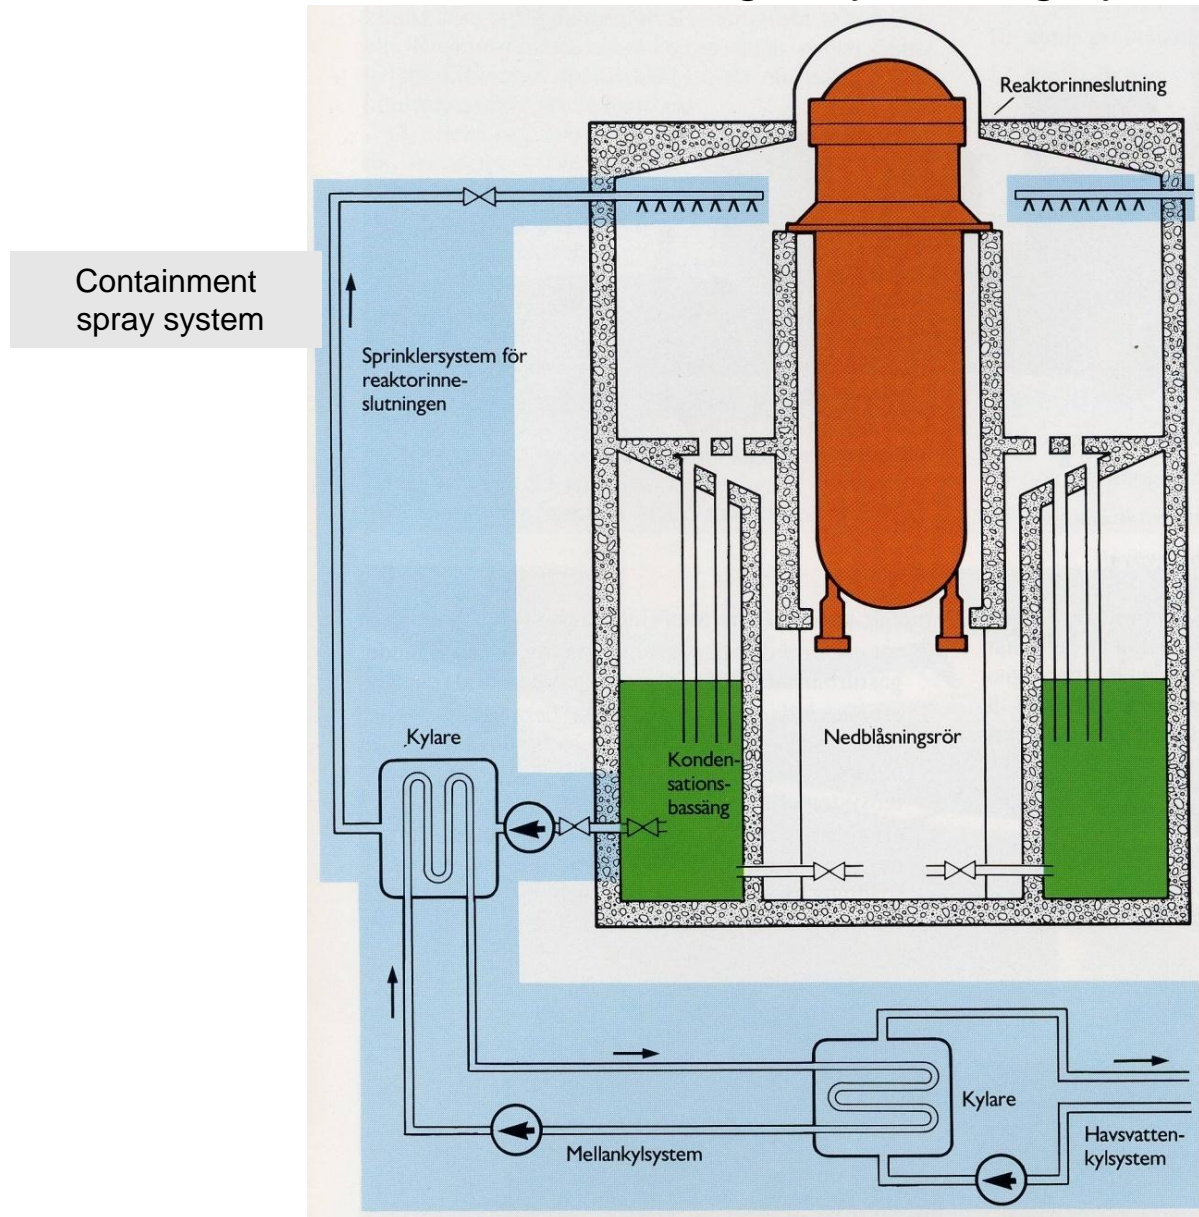
BWR – Containment emergency cooling system
